# Whanganui Estuary 2017 Broad Scale Habitat Mapping

Horizons Report 2017/EXT/1532

June 2017  
Report No. 2017/EXT/1532  
ISBN 978-1-927259-92-4

Leigh Stevens and Barry Robertson  
Wriggle Limited  
PO Box 1622  
Nelson 7040  
[www.wriggle.co.nz](http://www.wriggle.co.nz)  
Telephone 021 417 936 or 0275 417 935

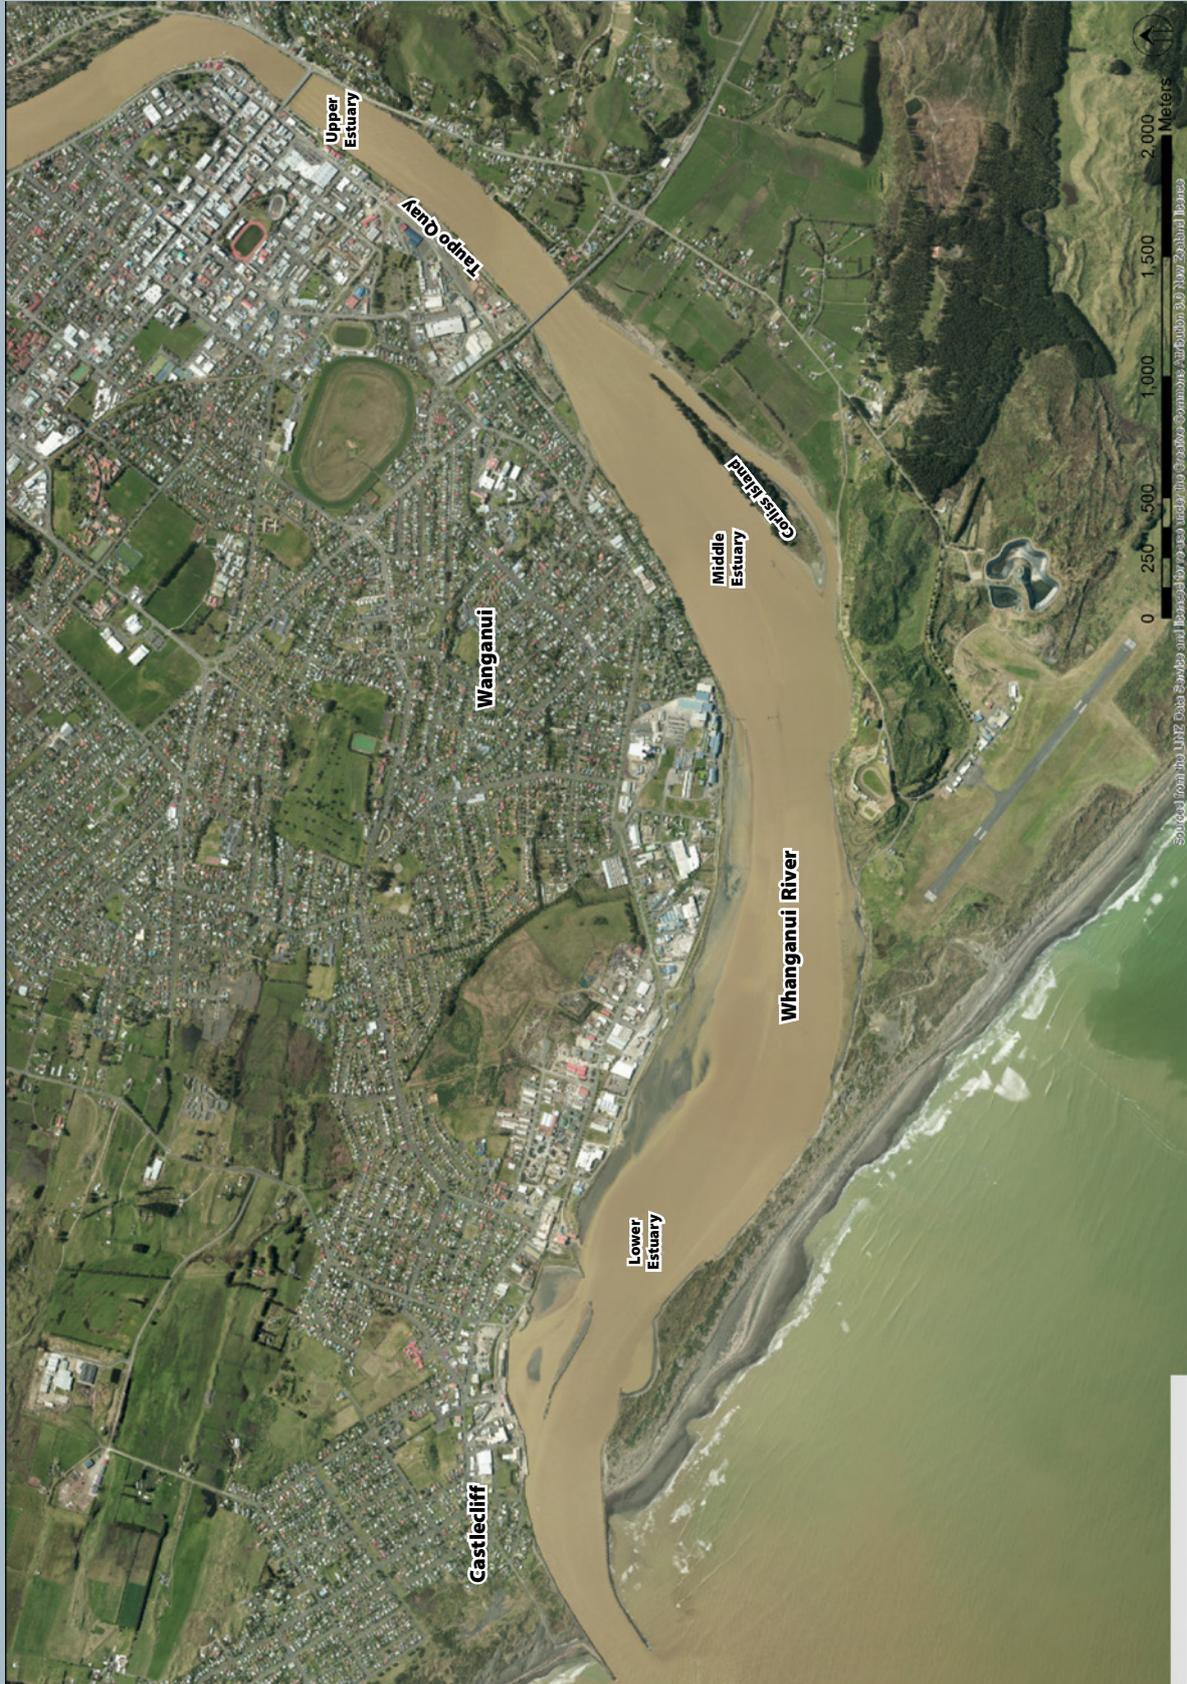
Figure 1. Whanganui Estuary, showing main estuary zones.

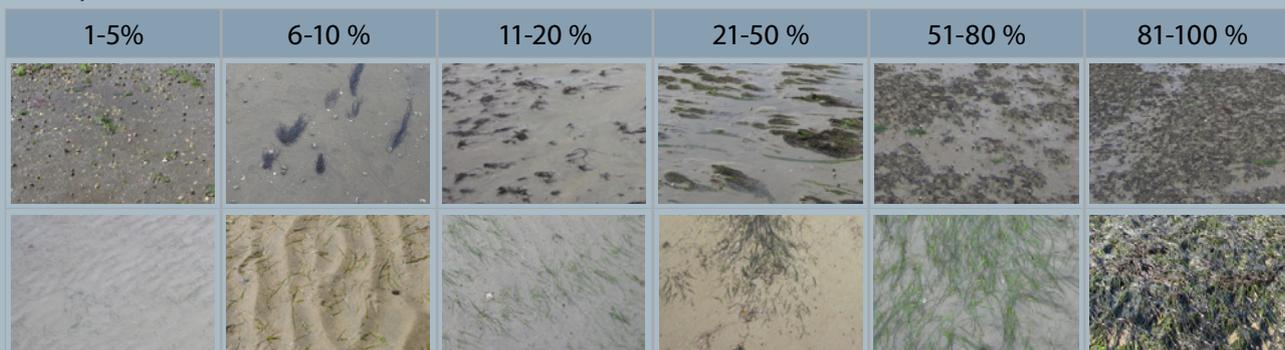
**Figure 2. Visual rating scale for percentage cover estimates of macroalgae (top) and seagrass (bottom).**

Where macroalgal cover exceeded 5% of the Available Intertidal Habitat (AIH), a modified Opportunistic Macroalgal Blooming Tool (OMBT) is used to rate macroalgal condition. The OMBT, described in detail in Appendix 2, is a 5 part multimetric index that produces an overall Ecological Quality Rating (EQR) ranging from 0 (major disturbance) to 1 (minimally disturbed) and which is placed within overall quality status threshold bands (i.e. bad, poor, good, moderate, high - Appendix 2). This integrated index provides a comprehensive measure of the combined influence of macroalgal growth and distribution. Broad scale habitat features were digitised into ArcMap 10.5 shapefiles using a Wacom Cintiq21UX drawing tablet, and combined with field notes and georeferenced photographs, to produce habitat maps showing the dominant cover of: substrate, macroalgae (e.g. *Ulva*, *Gracilaria*), saltmarsh vegetation, and the 200m wide terrestrial margin vegetation/landuse. These broad scale results are summarised in Section 4, with the supporting GIS files (supplied as a separate electronic output) providing a much more detailed data set designed for easy interrogation to address specific monitoring and management questions.

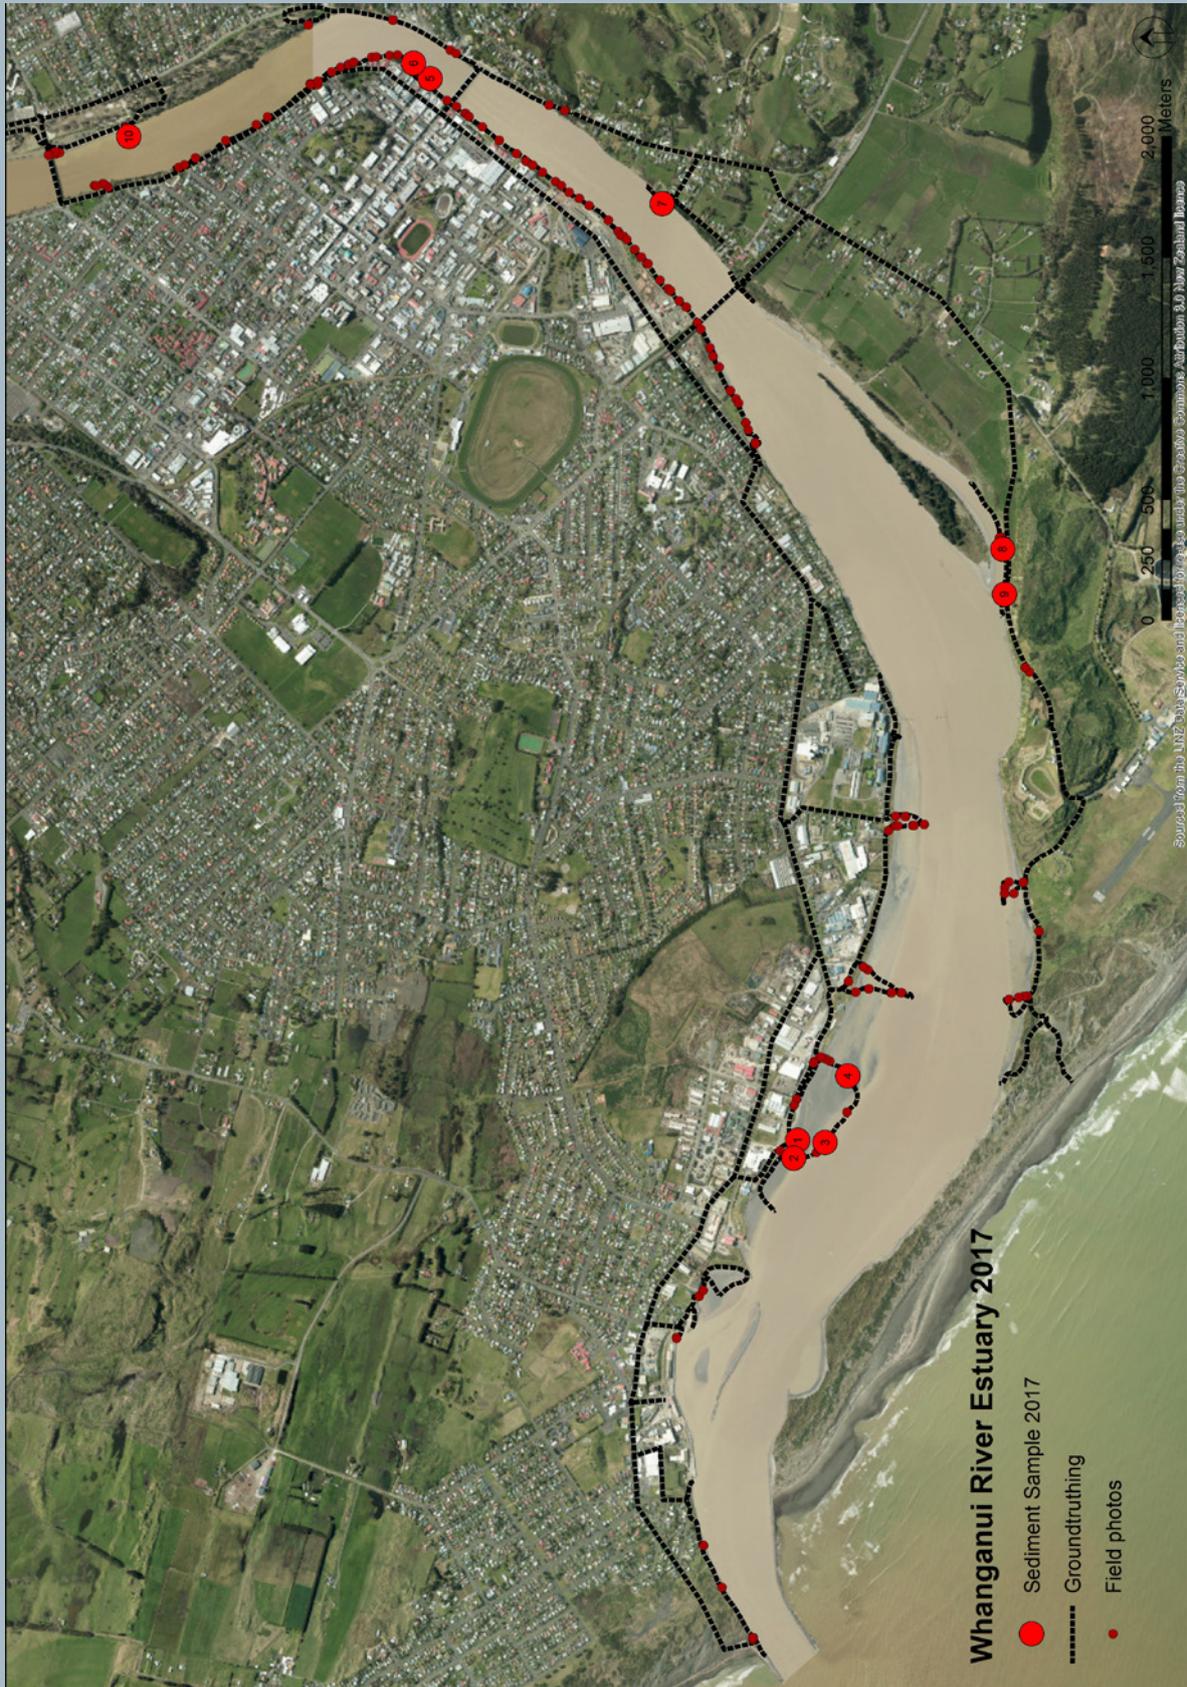
Figure 3. Whanganui Estuary - mapped estuary extent showing ground-truthing coverage, location of grain size samples used to validate substrate classes, and location of field photos.

<sup>1</sup>sites shown in Figure 3.

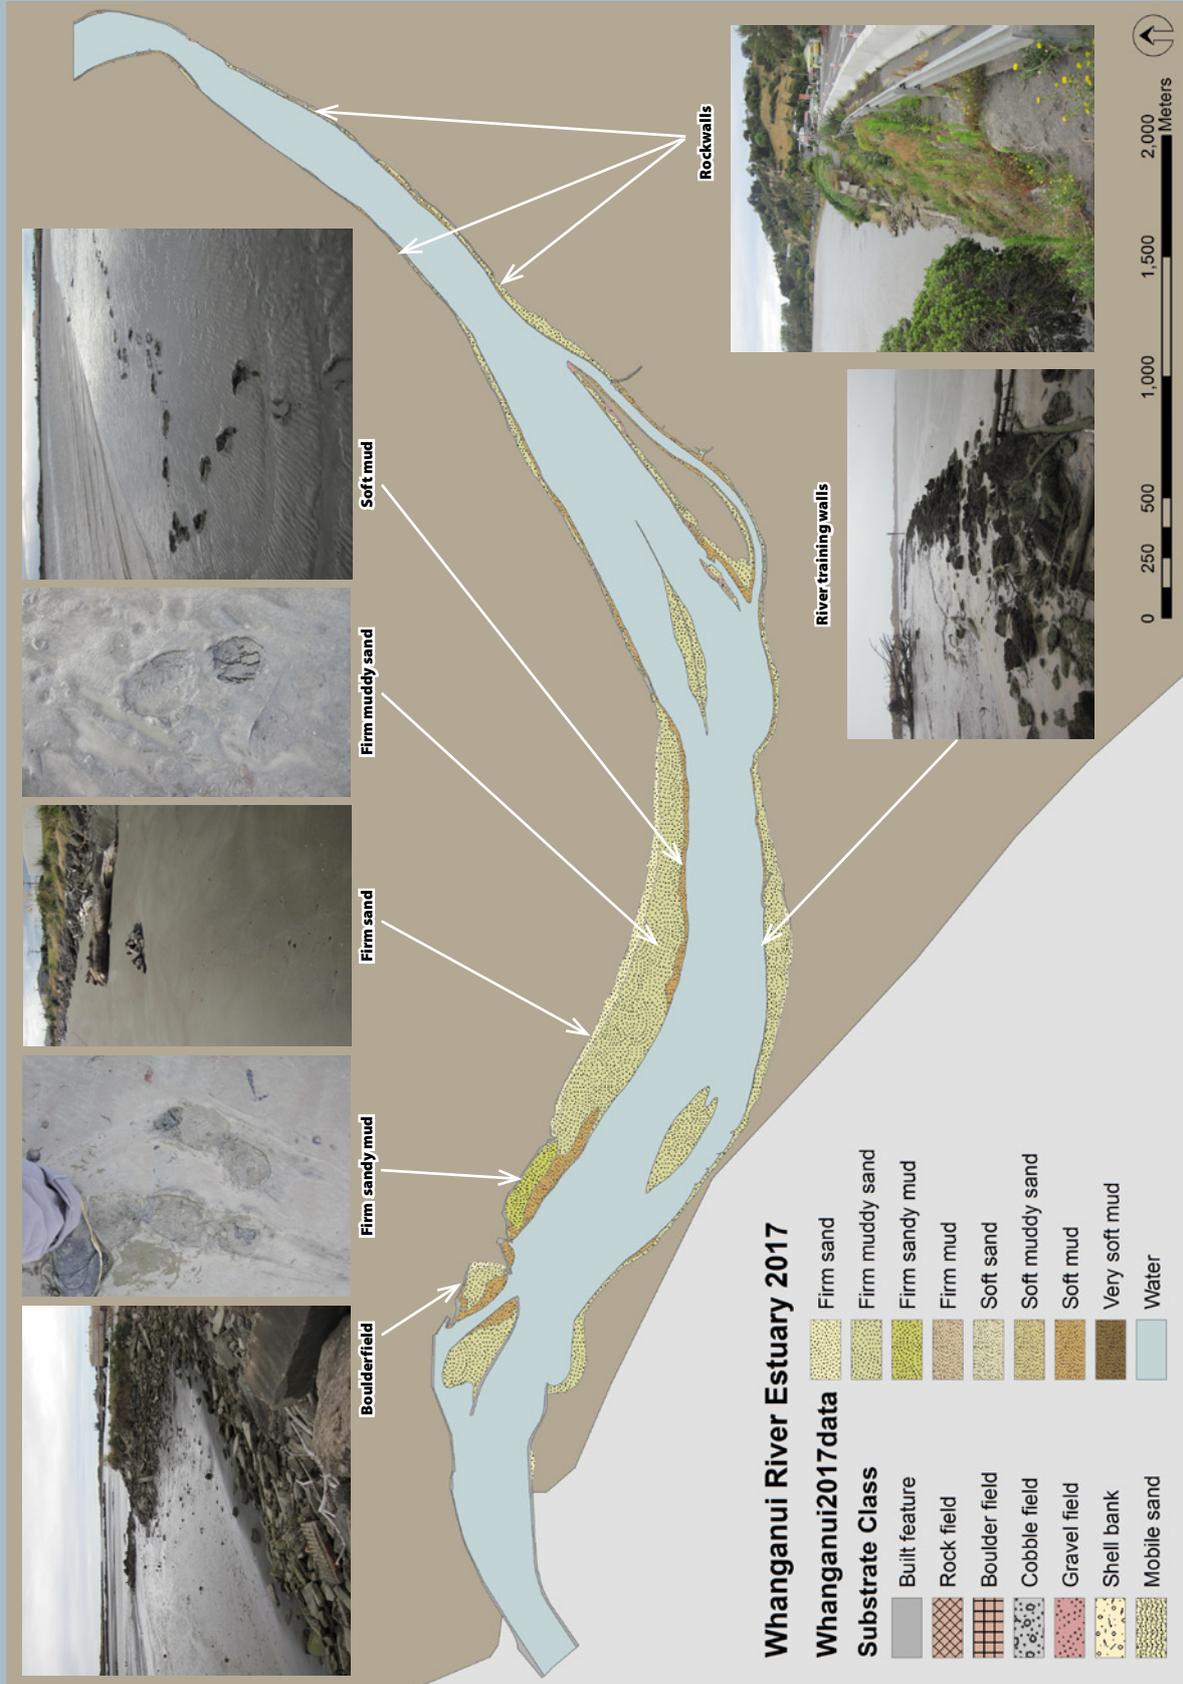
Figure 4. Map of dominant intertidal substrate types - Whanganui Estuary, 2017.

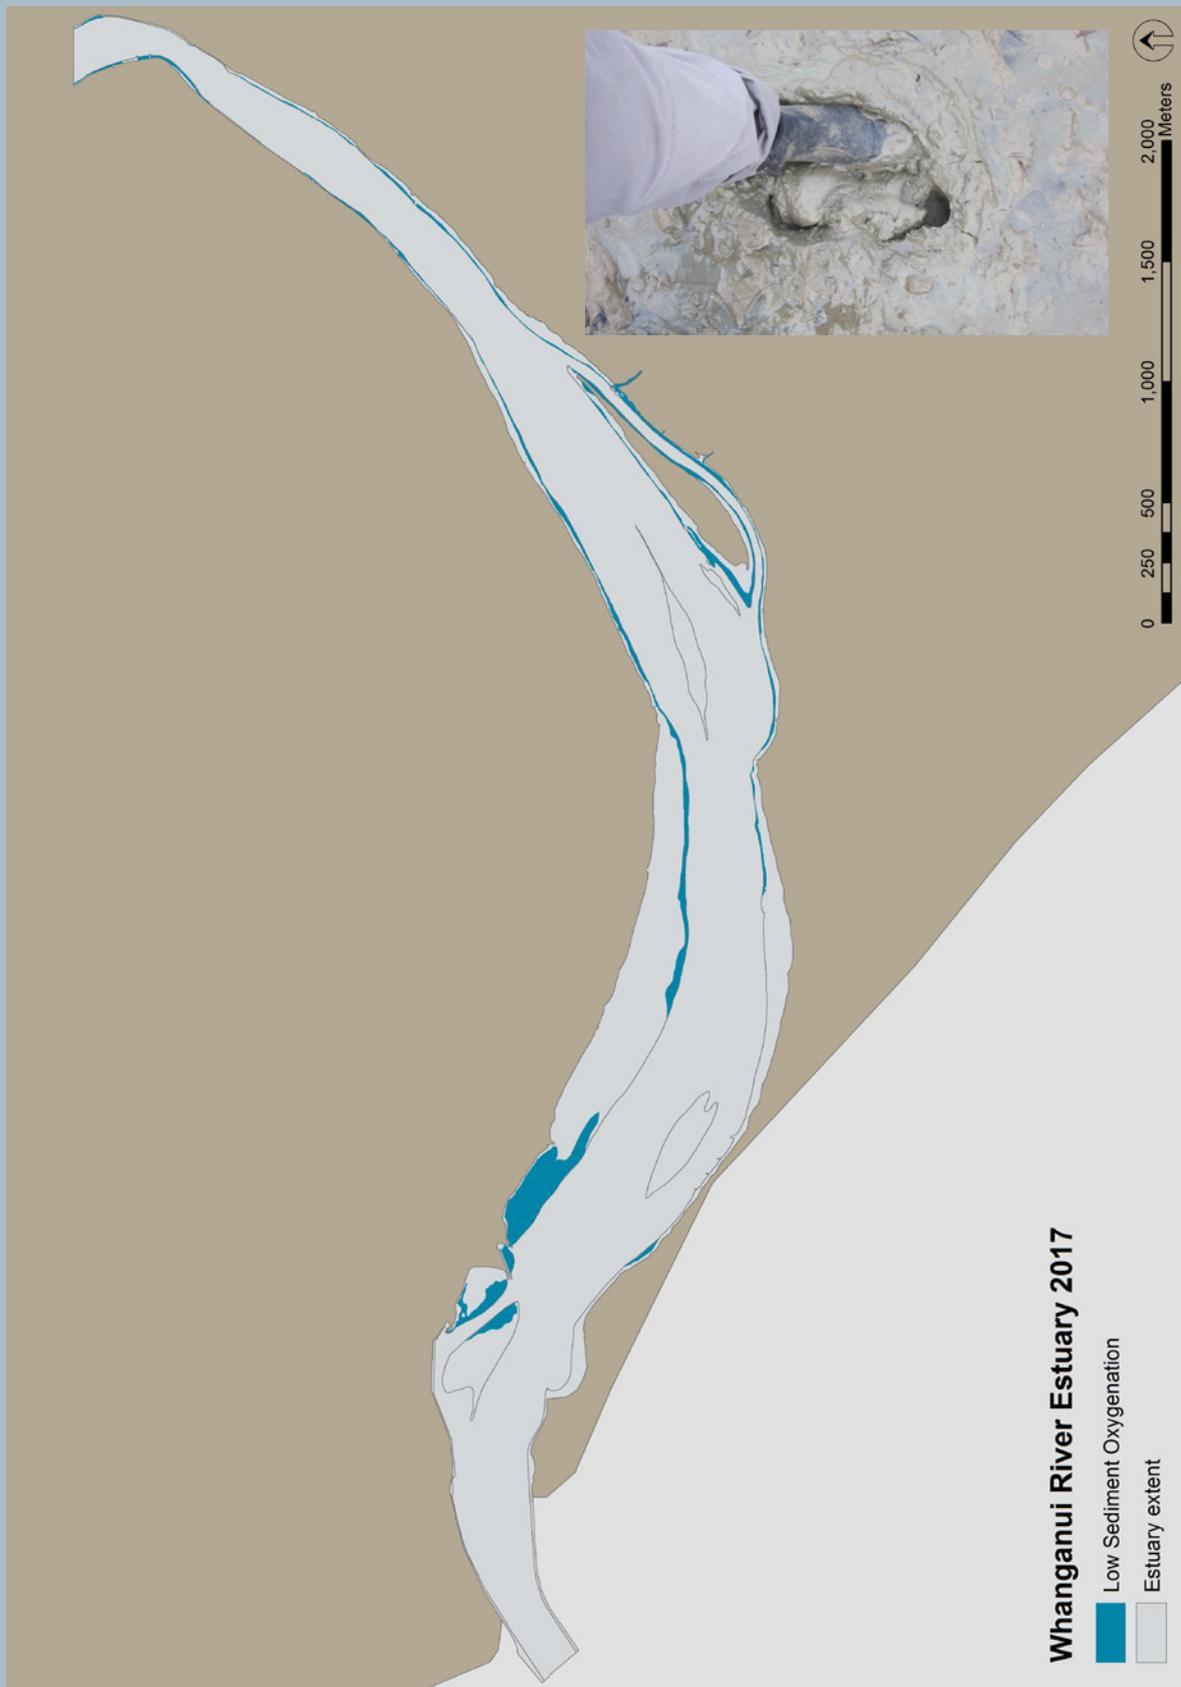
Figure 5. Map of areas with low sediment oxygenation - Whanganui Estuary, 2017.

The primary indicators used to assess sediment oxygenation are aRPD depth and RP measured at 3cm. aRPD was assessed at representative sites throughout the dominant sand and mud substrate types and from these results broad boundaries have been drawn where sediment oxygen is depleted to the extent that adverse impacts to macrofauna (sediment and surface dwelling animals) are expected, i.e. aRPD <0.5cm deep (Figure 6). Because macrofauna are used as an indicator of ecological impacts to other taxa, it is expected that these zones will also be exerting adverse impacts on associated higher trophic communities including birds and fish. These results show that the majority of the estuary sediments are well to moderately well oxygenated and appeared in good (healthy) ecological condition, with the aRPD depth at 2-5cm (i.e. RP above -150mV at 3cm) in most sand and gravel dominated sediments. Intertidal soft mud areas (16ha, 17%) were identified as having depleted sediment oxygen, a NZ ETI risk rating of HIGH. Sediment oxygenation in 2009 was rated MODERATE and indicates a decline in condition from 2009 to 2017.

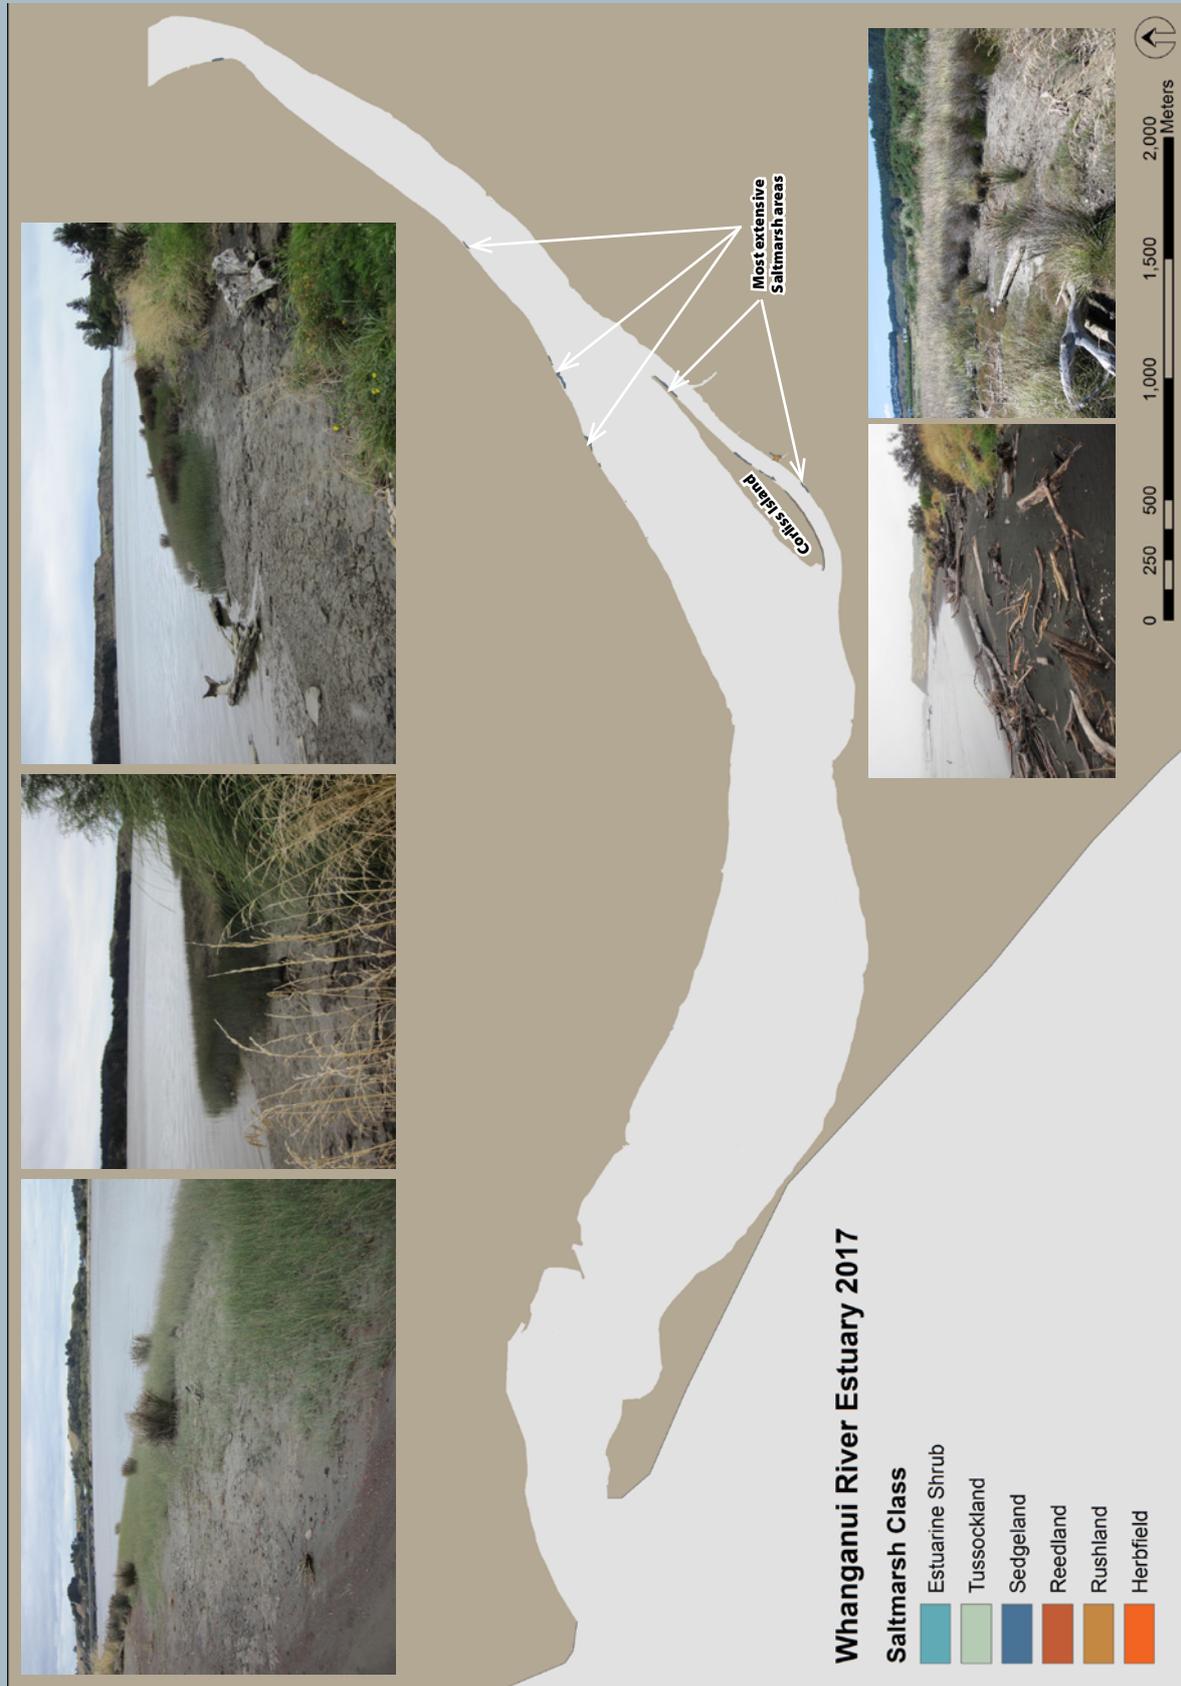
Figure 6. Map of dominant saltmarsh cover - Whanganui Estuary, 2017.

The primary measure to assess saltmarsh condition is the percent cover of the intertidal area. Table 6 and Figure 6 summarise the 2017 results and show saltmarsh was very sparse, present across 0.5ha (0.1%) of the intertidal estuary area, a risk indicator rating of HIGH. Saltmarsh comprised a relatively even mix of sedgeland (59%) and rushland (41%) located in relatively narrow strips along the estuary margins (Figure 6). Common within rushland (searush) areas (most located near Corliss Island) was a subdominant herbfield cover of primrose, with remuremu and glasswort. Tall fescue and a range of introduced weeds and grasses were common in the upper tidal range, particularly where margins have been modified. While frequent inundation with saltwater will limit the ingress of terrestrial weeds within saltmarsh, this natural control process is likely to be less effective in the upper tidal reaches where there is a strong freshwater (river dominated) influence (i.e. upper tidal areas will be inundated largely by freshwater that floats on top of denser seawater).

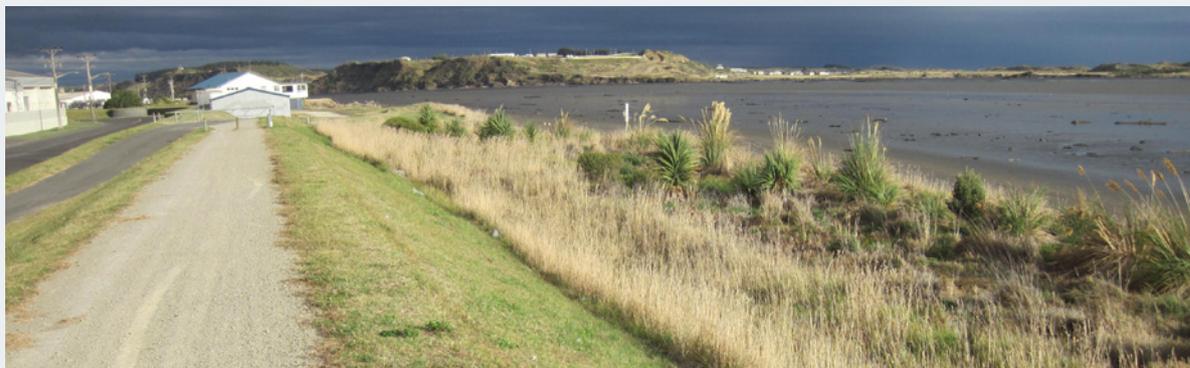
A narrow strip of terrestrial plantings between the river floodbank and lower estuary intertidal flats. Extensive areas of saltmarsh would have historically been present across the (now reclaimed) estuary flood delta.

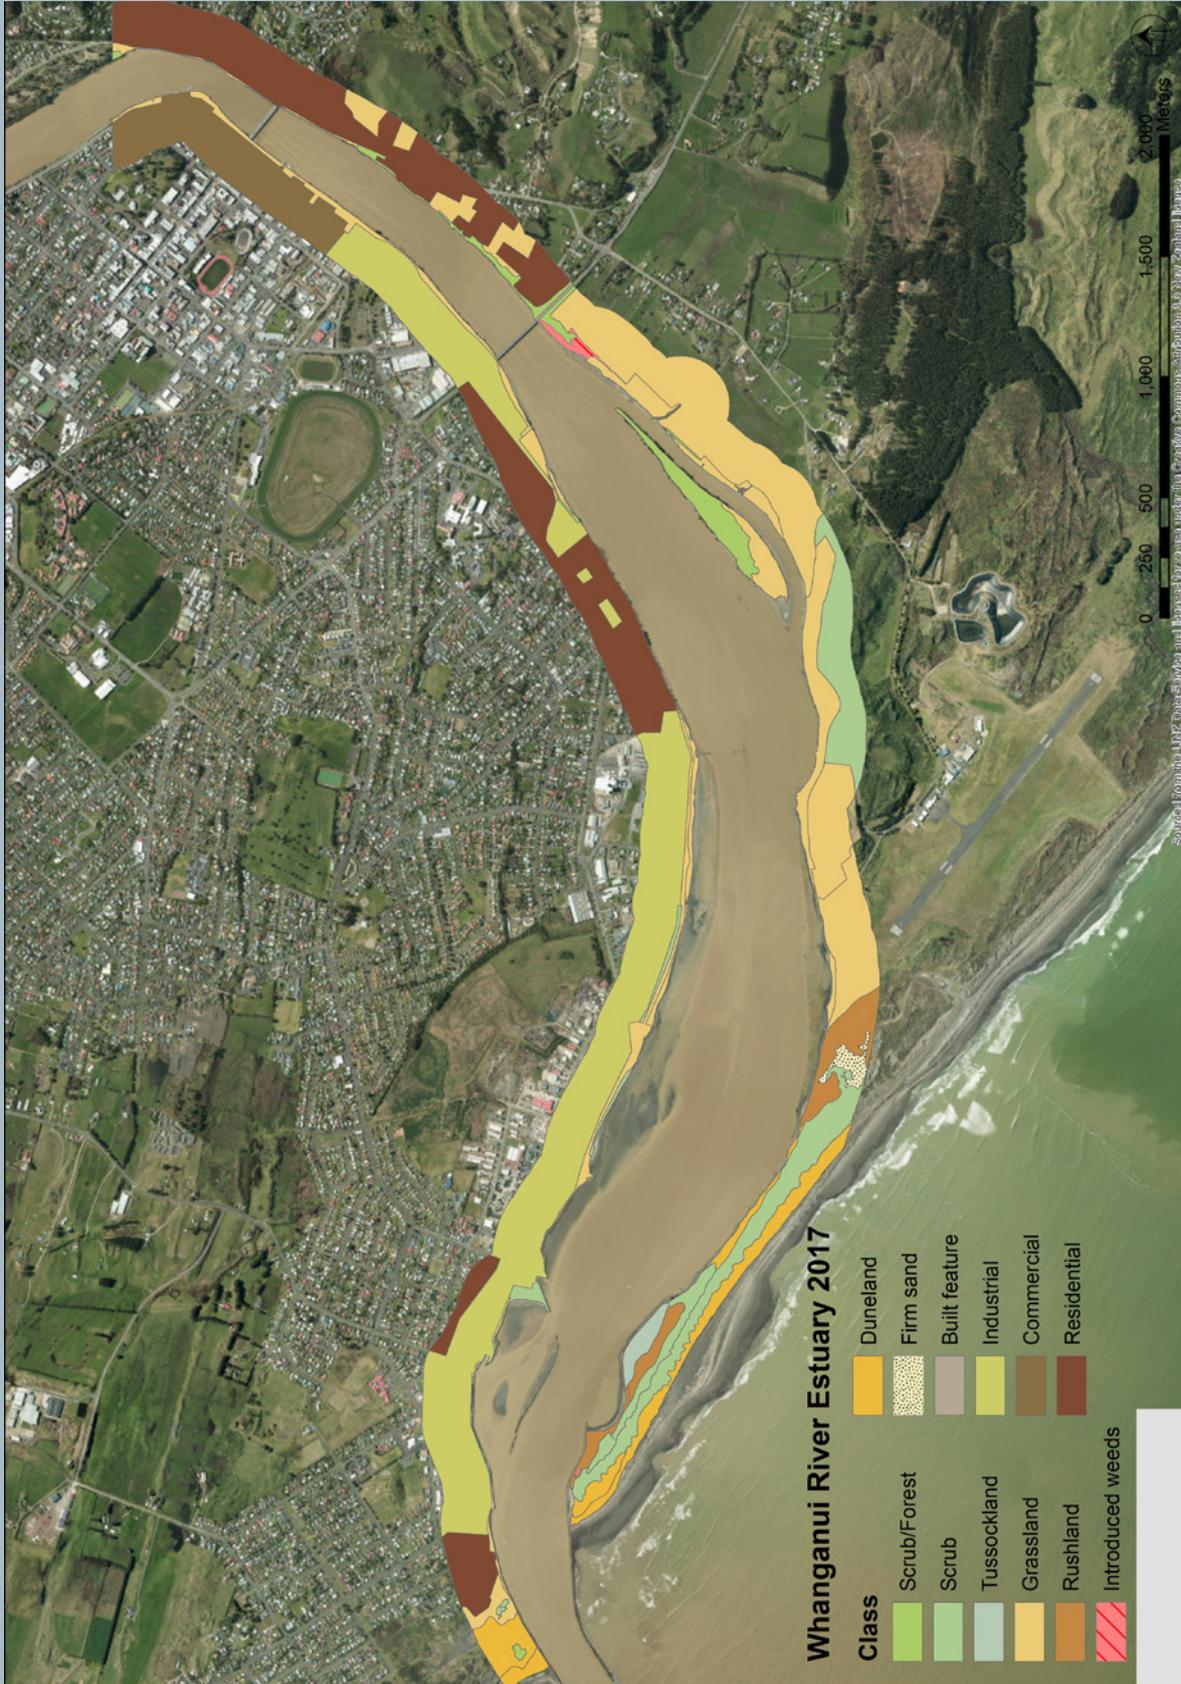
Figure 7. Map of 200m Terrestrial Margin - Dominant Land Cover, Whanganui Estuary, 2017.

Class	Dominant features	Percentage
Scrub/Forest	Large mainly exotic trees on the south (true left) side and Corliss Island.	2.6
Scrub	Mixed native and exotic species often amenity plantings in a relatively narrow strip on the north (true right) side of the estuary	9.7
Tussockland		0.7
Rushland	Upper reaches where tidal surge floods margins largely with freshwater	2.8
Grassland	Pasture and unmanaged grassland on the south side of the estuary	25.0
Introduced weeds	Middle estuary, south (true left) side.	0.3
Duneland	Barrier spit near the estuary entrance	4.9
Residential	Predominantly middle and upper estuary areas.	20.8
Commercial	Upper estuary, north (true right) side.	6.3
Industrial	Lower estuary, north (true right) side.	26.1
Unvegetated	Small areas of sand on the barrier spit near the entrance.	0.6
<b>Total</b>		<b>100</b>

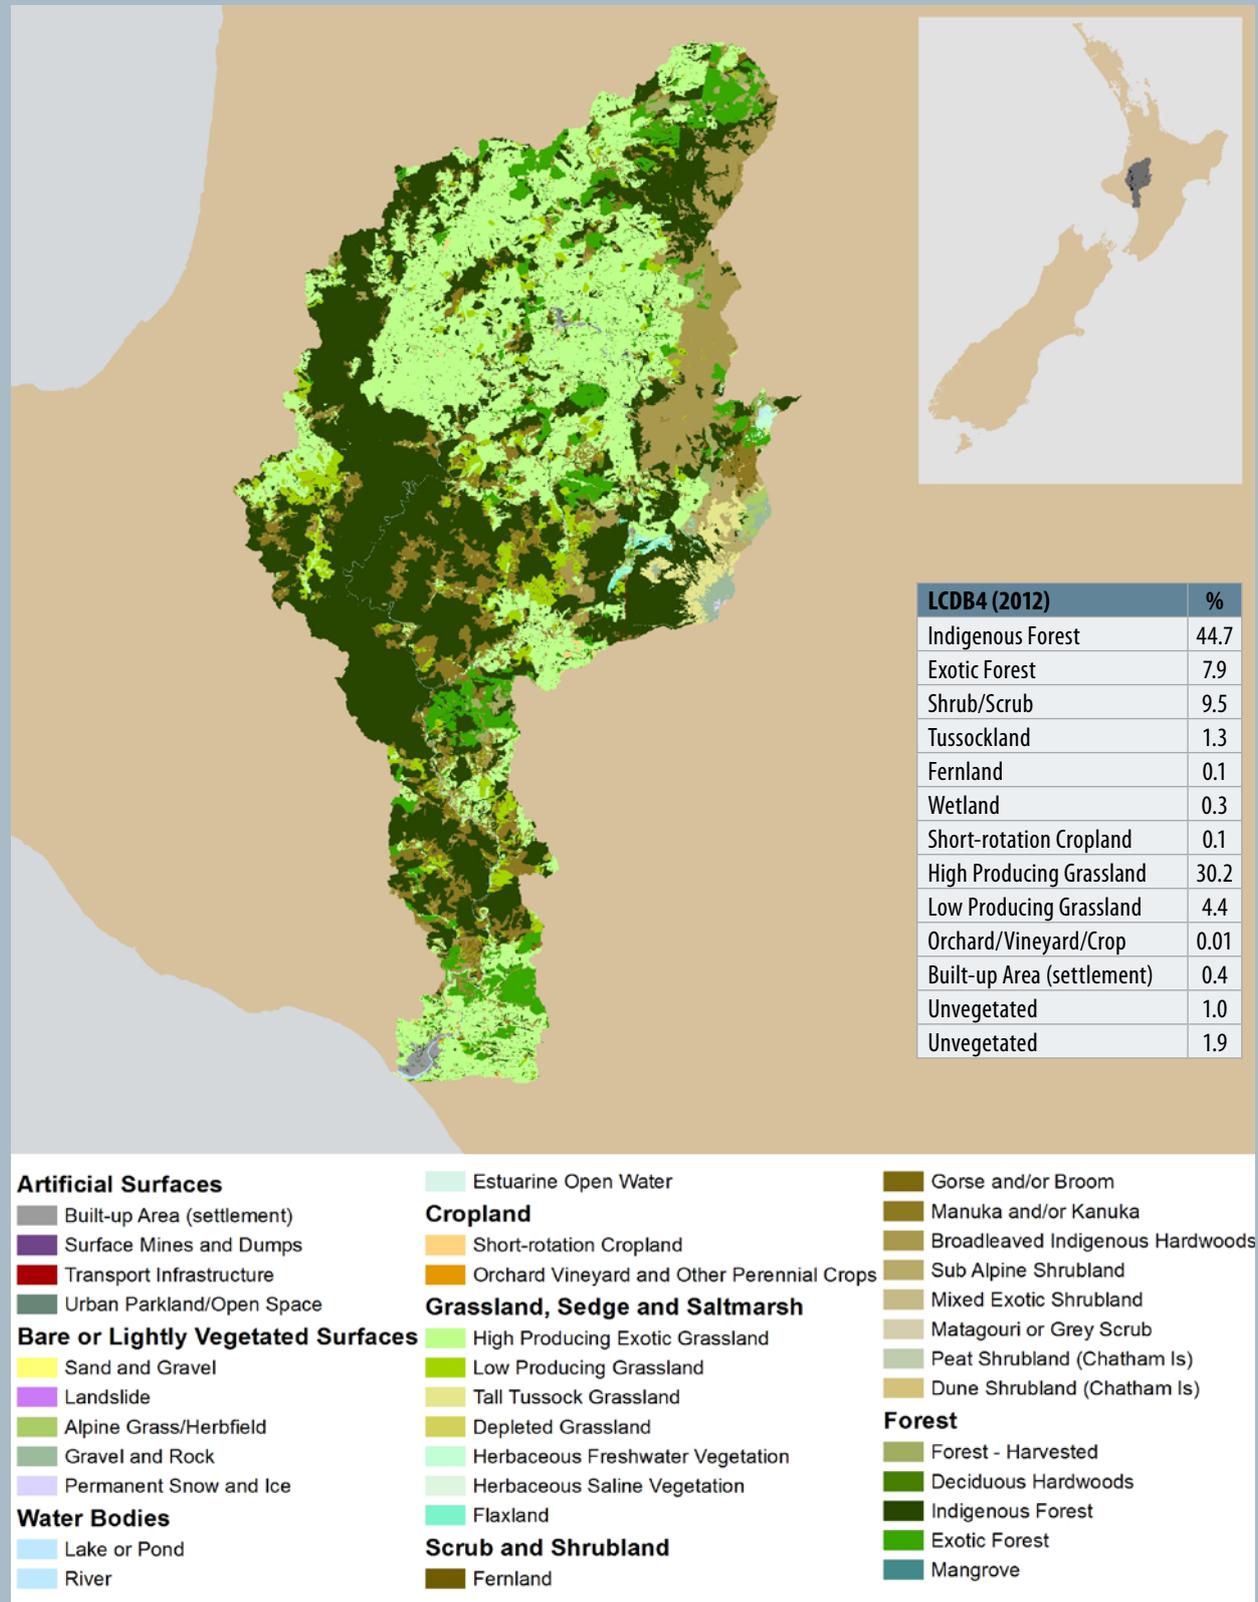
Figure 8. Summary of Catchment Land Cover (LCDB4 2012), Whanganui Estuary.

Figure 8 summarises land use within the large (7169km<sup>2</sup>) estuary catchment and highlights the dominance of native forest (45%) and high producing grassland (30%), and smaller extents of mixed scrub and shrub (11%) and exotic forest (8%). Built-up areas (settlements) comprise 0.4% of the catchment. The extent of densely vegetated 200m terrestrial margin habitat (21%) will provide some buffering against adverse ecological degradation (e.g. localised sediment and nutrient input mitigation). However, in the Whanganui Estuary, a risk indicator rating of HIGH has been applied for the following reasons:
