Salt Ecology Short Report 008. Prepared by Barrie Forrest for Otago Regional Council, March 2022

Since Dec-2016, Otago Regional Council has undertaken annual State of the Environment monitoring in Shag Estuary to assess trends in the deposition rate, mud content, and oxygenation of intertidal sediments. Sediment monitoring is undertaken at two sites (Fig. 1), with the latest survey carried out on 24 November 2021.

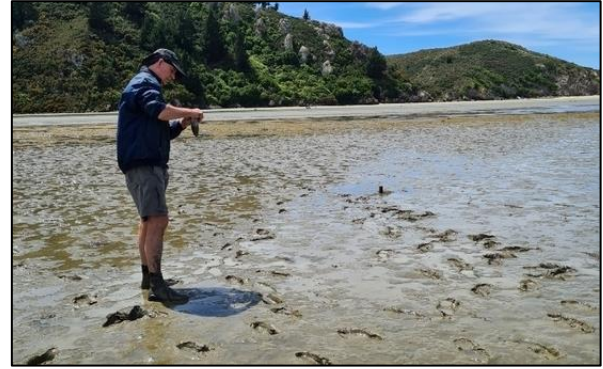
Sediment mud content was rated as 'poor' at both sites in Nov-2021 as it exceeded the biologically relevant threshold of 25%. At Site A, mud content has nonetheless declined since the Jan-2021 deposition event referred to above (Fig. 3).

Muddy surface sediments at Site A in Nov-2021

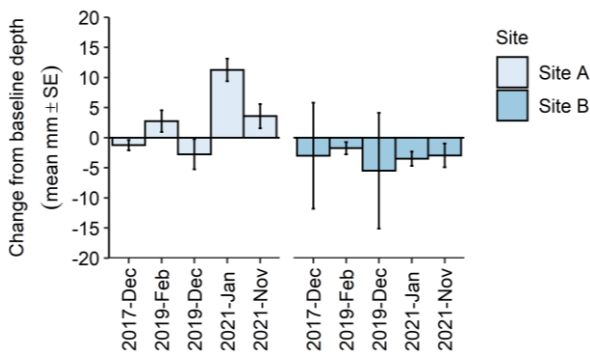
Fig. 2. Change in mean sediment depth over buried plates ( $\pm$ SE) relative to the baseline.

The cumulative change in sediment depth over plates at each site is shown in Fig. 2. The mean sedimentation rate over the past 5 years has been low, corresponding to condition ratings of ‘good’ and ‘very good’ at Sites A and B, respectively (Table 1). Sedimentation has been highly variable across surveys. At Site A, a significant deposition event in Jan-2021 was followed by subsequent erosion in the period preceding the latest survey. The temporal variance in erosion and accretion at both sites likely reflects the river-dominated hydrological setting, periodic restriction of the estuary entrance, and
