Salt Ecology Short Report 005. Prepared by Barrie Forrest for Otago Regional Council, March 2022

**OVERVIEW**

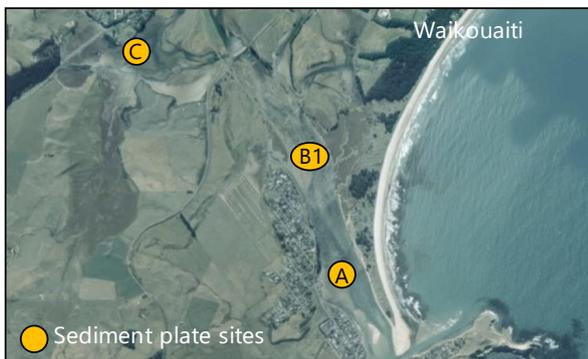
Fig. 1. Location of Waikouaiti Estuary monitoring sites. Site B1 replaced nearby Site B, which was washed away.

Since Dec-2016, Otago Regional Council has undertaken annual State of the Environment (SOE) monitoring in Waikouaiti Estuary to assess trends in the deposition rate, mud content, and oxygenation of intertidal sediments. Sediment monitoring is undertaken at three sites (Fig. 1), with the latest survey carried out on 24 November 2021.

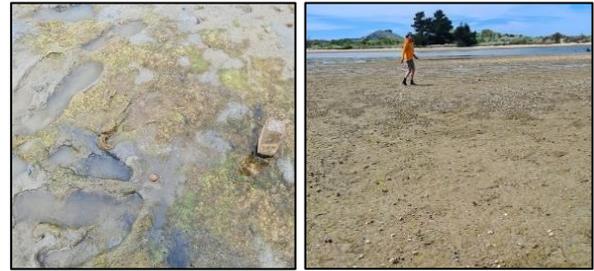
The relatively deep aRPD depth of 50mm at Site A (condition rating ‘very good’, Table 2) likely reflects the sandy sediment at this site, with oxygenation also maintained by the presence of crabs, numerous cockles and other organisms, which turn over surface sediments and create voids that allow air and water to transfer oxygen to underlying layers. The relatively shallow aRPD at Sites B1 and C is indicative of moderate organic enrichment, with condition ratings of ‘poor’ and ‘fair’, respectively. At Site C there were also moderate growths of filamentous algae (see photo) that had not been recorded previously.

Algal growth at Site C (left) and firm sand with cockles at Site A (right) in Nov-2021.
